Building and Site Analysis

Presented To:
Ransom District Library

January 17, 2012

RANSOM DISTRICT LIBRARY

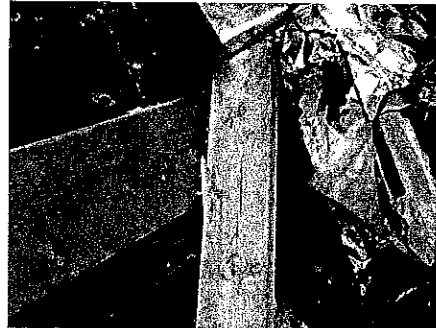
Another critical issue is the pulling apart of the roof trusses along the original buildings north wall. C2AE observed that as the north wall has settled and rotated away the roof trusses have pulled away from their supporting components (walls, girder trusses, etc.). It appears that some corrective measures have been installed to prevent failure to the worst trusses, but more needs to be employed if the library decides to stay long term, or expand the current facility.

Roof truss movement

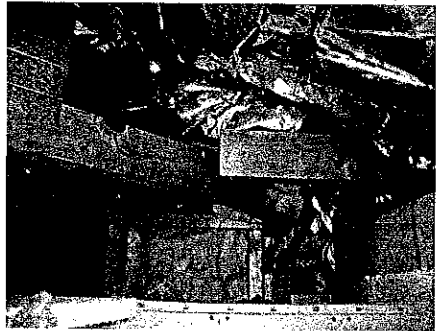
Roof truss movement

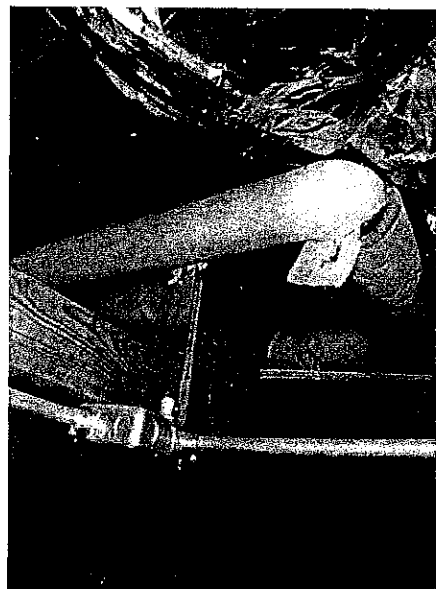
Roof truss repair

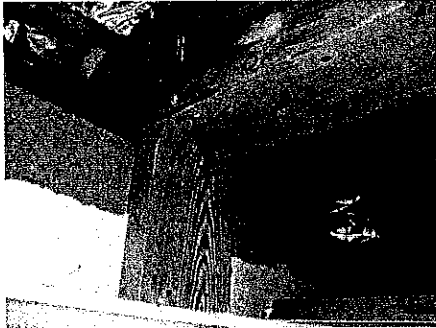
Roof truss movement

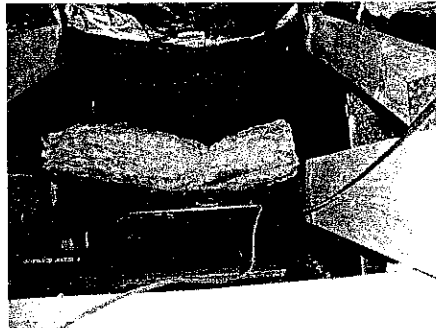
Falling roof truss

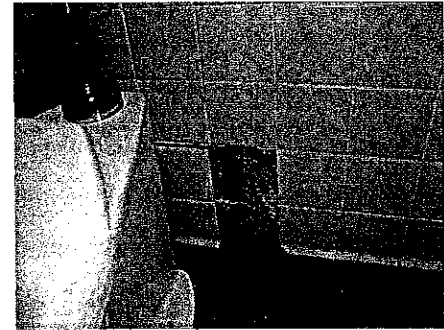
Crack in wall due to settlement

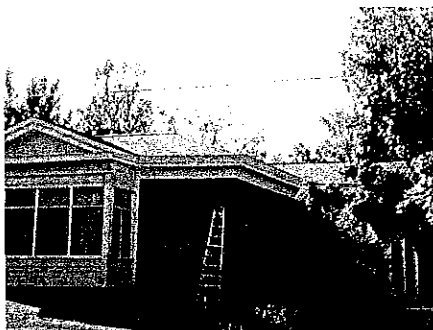
Sagging eave line

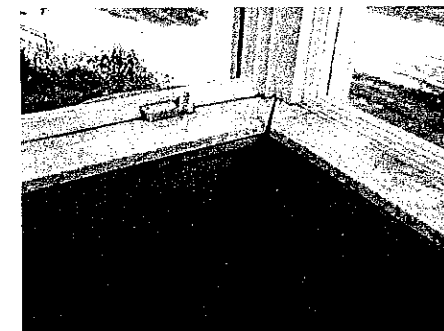
More evidence of movement

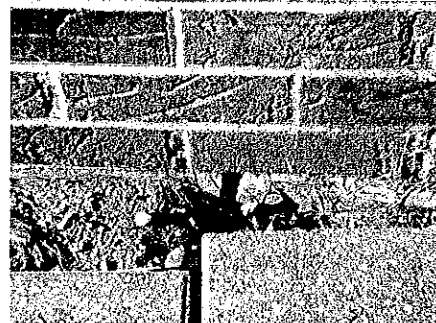
Cracking in foundation wall
due to settlement

1. The north wall extending around the east corner to the bay should be removed including the foundation and it should be replaced with a new bearing wall resting on either piles or helical piers.
2. The roofing and sheathing in this area should be taken off and any damaged roof trusses should be repaired or replaced.
3. The wood wedges under the joists in the crawl space should be removed and the joists should bear on either steel shims or solid grout.
4. The corroded form-deck around the stoop in the crawl spaces should be wire brushed to remove all corrosion and new deck support should be installed.

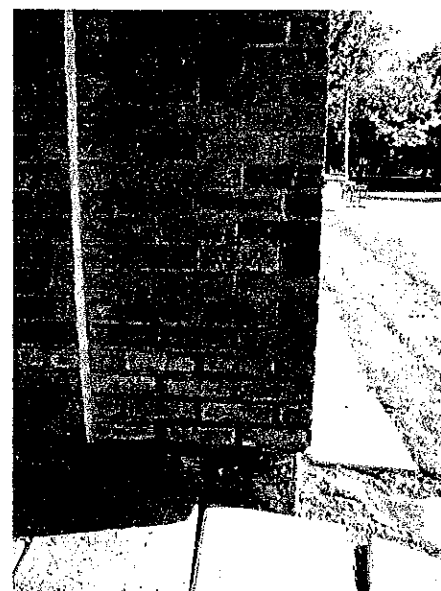
Previous crack repair

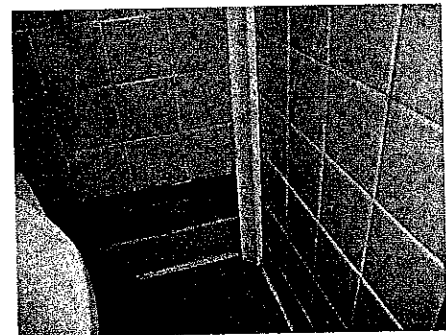
Crack in restroom stall

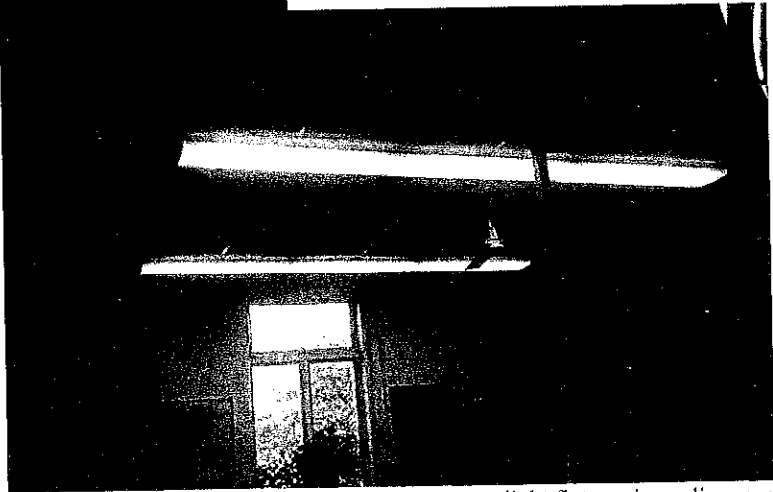
The lighting system consists of older fluorescent recessed troffer and surface mount T-12 light fixtures. Though fairly efficient compared to incandescent lighting, more efficiency can be had by replacing the current lighting fixtures with new T-8, or T-5 HO high performance lighting fixtures.

Surface mount light fixtures in reading area and offices
