Building and Site Analysis

Presented To:
Ransom District Library

January 17, 2012

RANSOM DISTRICT LIBRARY

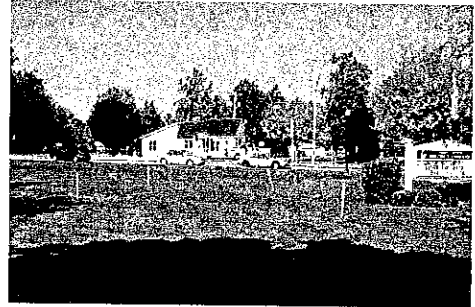
The soil borings and geotechnical report confirm that the entire site contains anywhere from 3 feet to 11 feet of poor soils, or a 6.5 foot average depth from the data. The soils contain a combination of dumped fill material (glass, wood, metals, bricks, concrete, paper, etc.) and peat (low strength/highly compressible) materials. The water table is anywhere from 6.2 to 10.5 feet below ground level, which is not unusual with the proximity along the Kalamazoo River. *We feel*

Soil boring locations at north portion of site

the ten (10) soil borings give us conclusive evidence of the sites former status as a local dump and the soil structure not being conducive to standard construction techniques. The geotechnical report contains more detailed information regarding construction recommendations of any future buildings on the site, as well as corrective measures to be employed to the current library building.
